GALION BAY DAM
(LAKE RENE)
NDI I.D. NO: PA-747
DER I.D. NO: 17-107

PHASE I INSPECTION REPORT
NATIONAL DAM INSPECTION PROGRAM

BY
D'APPOLONIA CONSULTING ENGINEERS
10 DUFF ROAD
PITTSBURGH, PA. 15235
JUNE 1979

GALION BAY DAM
NDI I.D. NO. PA-747
APRIL 3, 1979

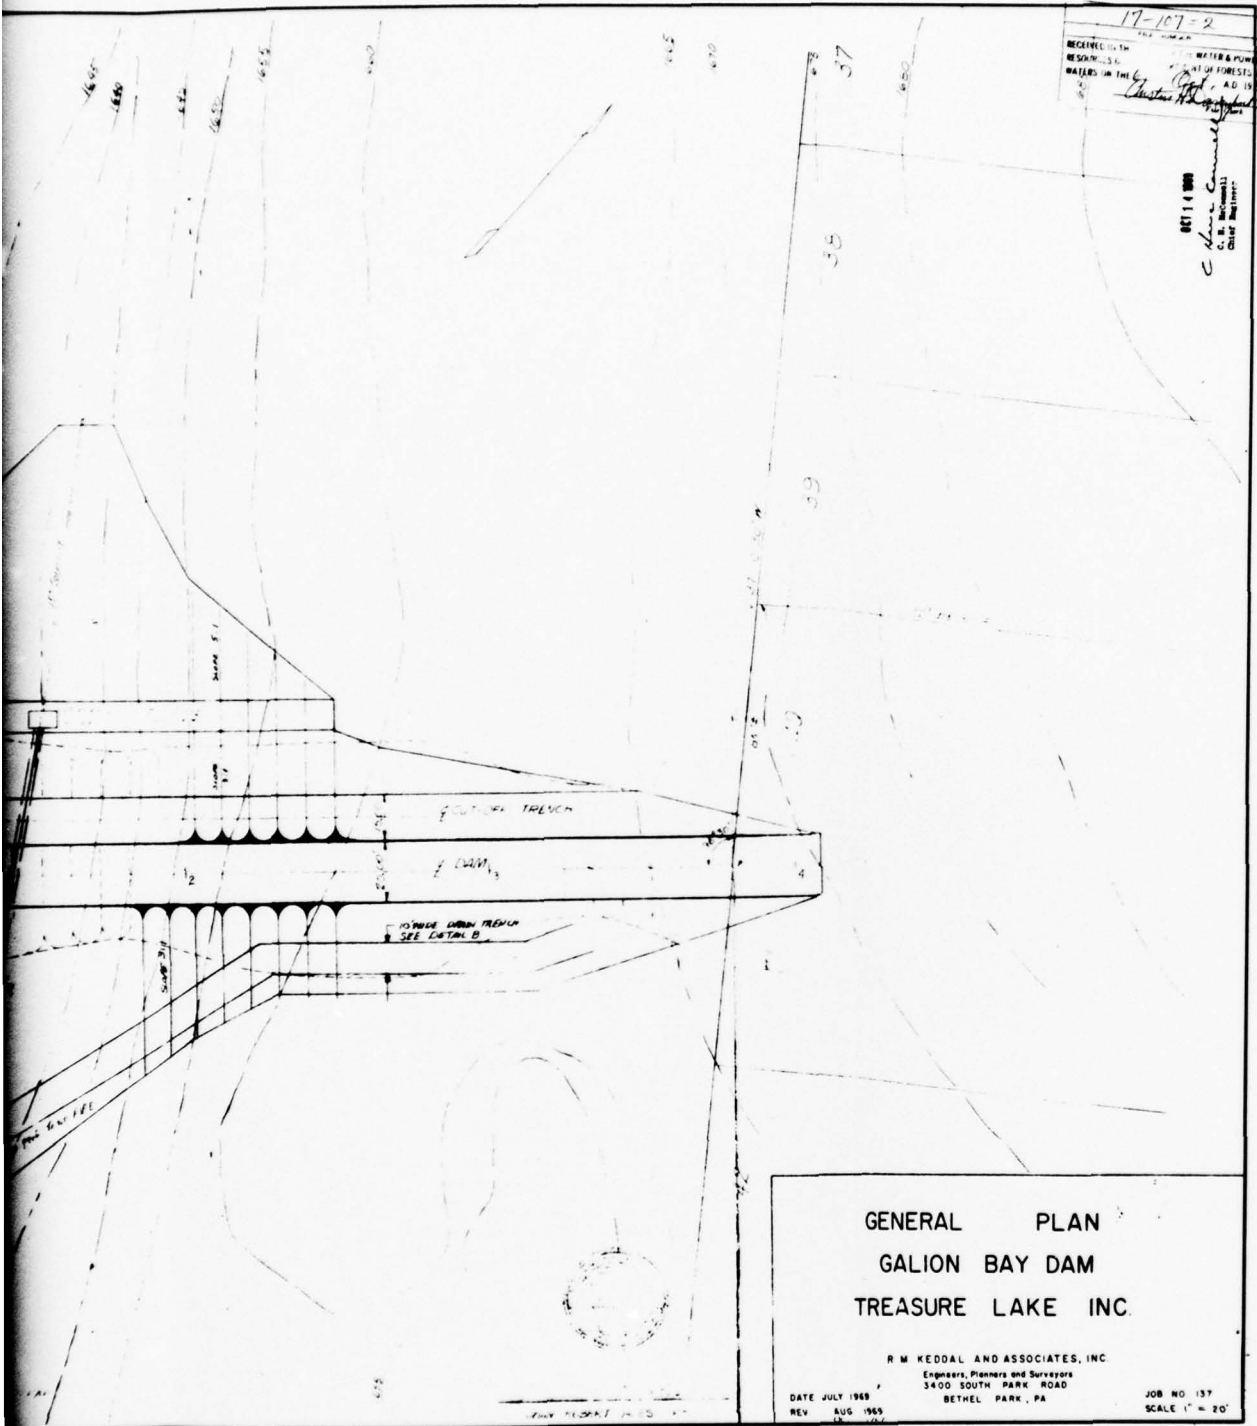
PLATE 2

GENERAL PLAN
GALION BAY DAM
TREASURE LAKE INC.

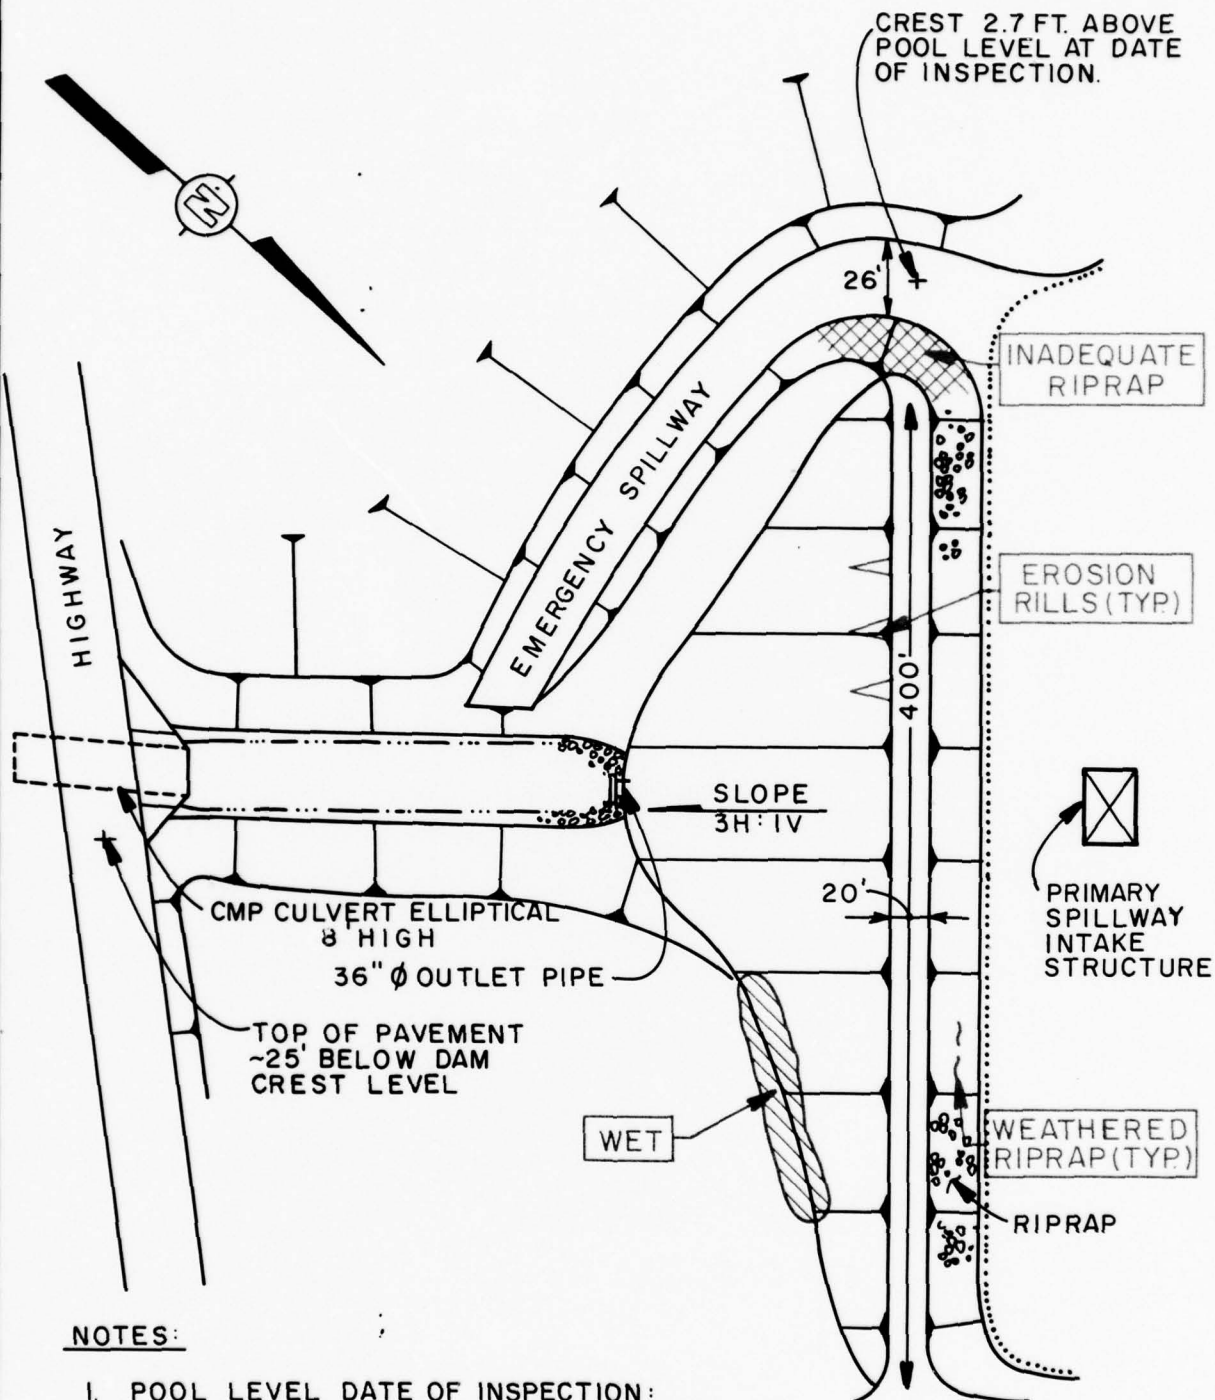
The top of the embankment was surveyed relative to the pool level on the date of inspection, which was estimated at Elevation 1662.6 and the lowest area on the crest of the embankment was found to be within 0.1 foot above the design elevation of 1670. The dam crest profile is illustrated on Plate 9.

1. POOL LEVEL DATE OF INSPECTION:
~0.2 FT. ABOVE PRIMARY SPILLWAY CREST
2. EMERGENCY SPILLWAY FREEBOARD =
7.5 FT.
